# POWERFLEX®

**PFR85-262G**

**Rear Trailing Arm Bush Adjustable**

## INSTALLATION GUIDE

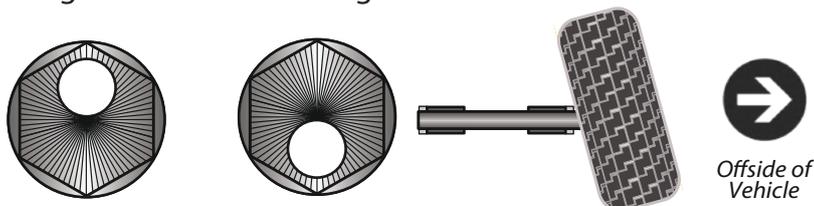
Note: Wheel angles are exaggerated for illustrative purposes.

Figure 1 - Maximum negative camber illustrated.

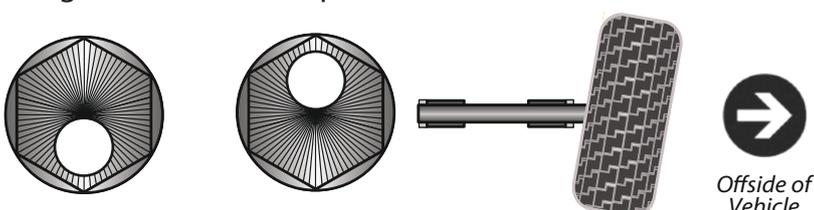
Figure 2 - Maximum positive camber illustrated.

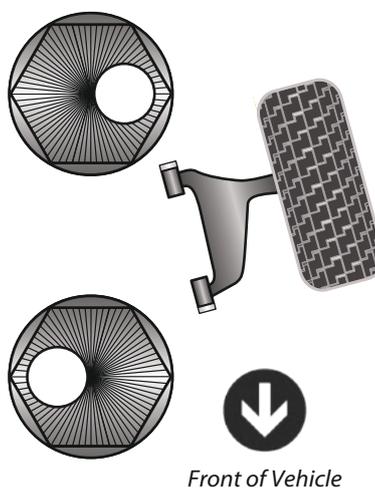
Figure 3 - Maximum positive toe angle.

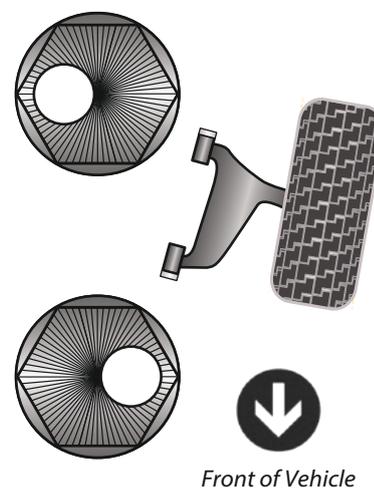
Figure 4 - Maximum negative toe angle.
